HOME INSPECTION REPORT

999 Sample Ave
Penticton, British Columbia

Prepared for: **Mr. & Mrs. Sample**

Prepared by: **Skyview Innovations Building & Development Consulting**
103-1219 Commercial Way
Penticton, BC V2A 3H4
Professionalism & Integrity; Our Hallmarks

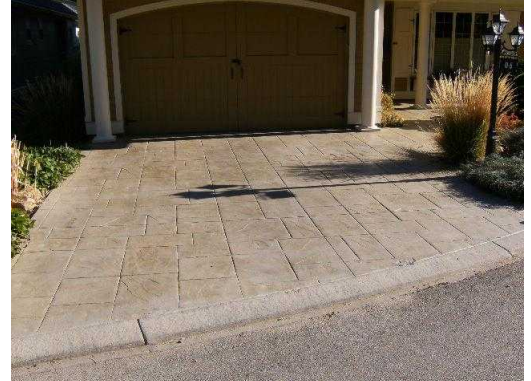
1. Acceptable Driveway: Concrete

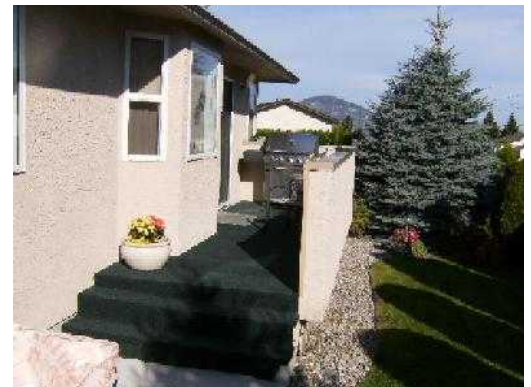
2. Acceptable Deck: Stained wood

3. See Comments Deck Surface Spaced decking, In-Out carpet in/out carpet over spaced decking, this is not a waterproof or rot resistant assembly, rotting of decking can be expected, recommend adding a water tight decking membrane or removing carpet

1. **Deck Surface** Spaced decking, In-Out carpet in/out carpet over spaced decking, this is not a waterproof or rot resistant assembly, rotting of decking can be expected, recommend adding a water tight decking membrane or removing carpet
2. **Vegetation:** Trees, Shrubs vines have caused staining and etching of siding, recommend that all vegetation be removed/separated from exterior cladding to prevent damage to cladding

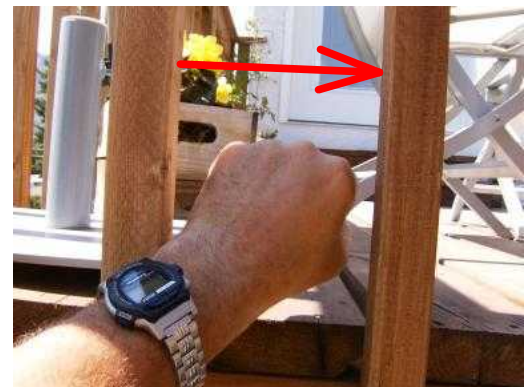
4. Acceptable Railings: Wood Pickets spacing too wide, safety item, recommend correction to within current standards

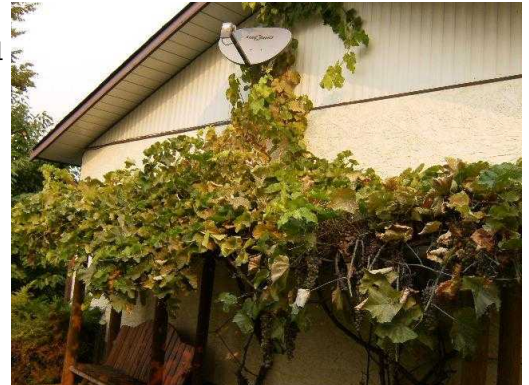
6. See Comments **Vegetation:** Trees, Shrubs vines have caused staining and etching of siding, recommend that all vegetation be removed/separated from exterior cladding to prevent damage to cladding

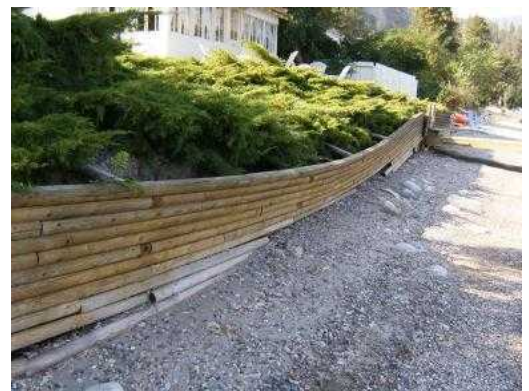
7. Defective **Retaining Walls:** Wood Leaning, Wall is unstable, Recommend repairs to avoid collapse

1. **Retaining Walls:** Wood Leaning, Wall is unstable, Recommend repairs to avoid collapse
-
2. **Main roof Attic Bathroom/kitchen Fan Venting:** Solid/smooth duct Bathroom improperly vents into attic and may cause moisture damage to the insulation, Recommend correction, Recommend adding duct wrap insulation to the duct to prevent condensation on the duct and resulting moisture problems

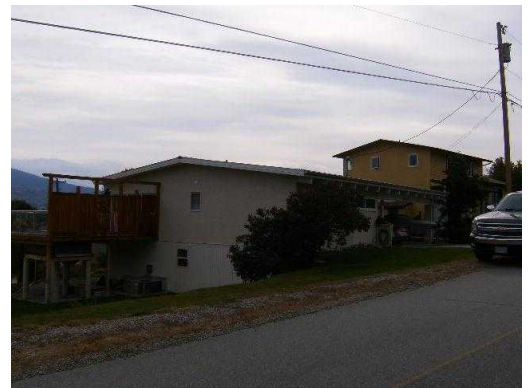
8. Acceptable **Grading:** Minor slope

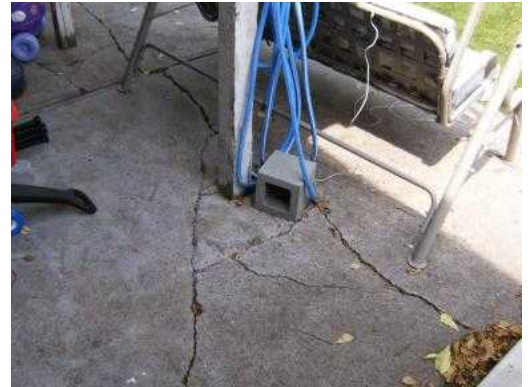
- 4. Acceptable Walls: Drywall
- 5. Marginal Floor Poured concrete slab Stored item / floor coverings prohibit a full inspection of floor, Cracked with displacement, recommend immediate repair to avoid tripping/injuries

1. **Floor** Poured concrete slab Stored item / floor coverings prohibit a full inspection of floor, Cracked with displacement, recommend immediate repair to avoid tripping/injuries

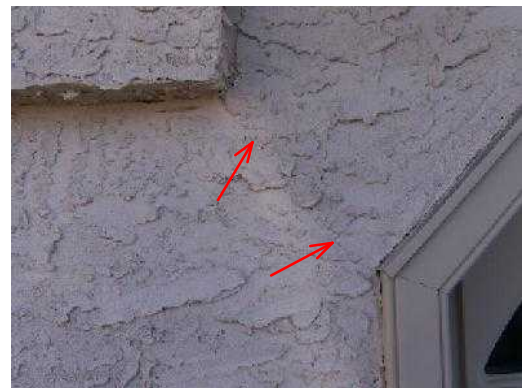
- 1. See Comments Type: Stucco Minor cracks

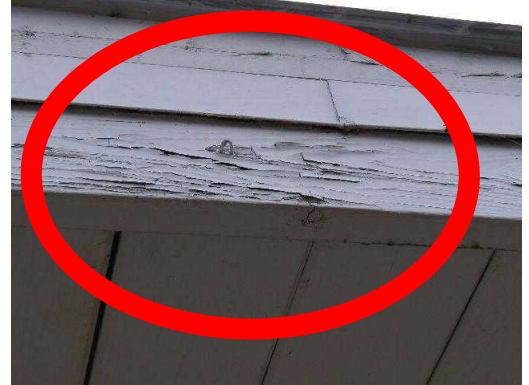
2. See Comments Fascia: Wood Paint peeling, Recommend paint/stain to extend the life of the component

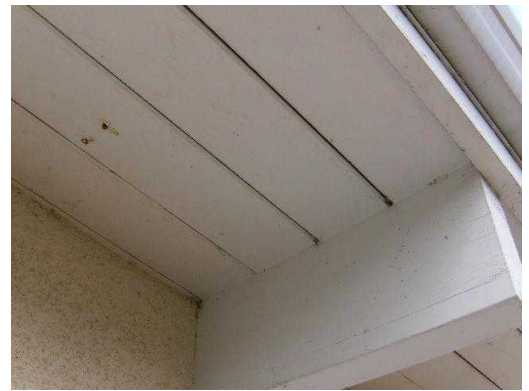
3. Acceptable Soffits: Aluminum, Fully vented

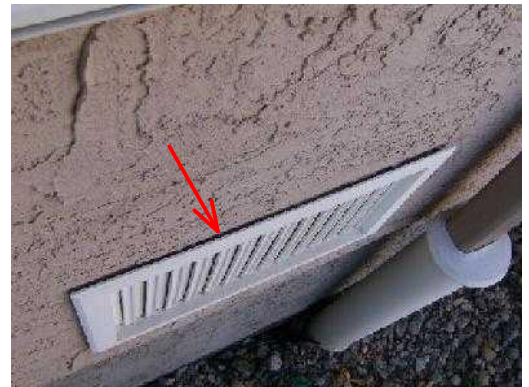
4. Not Present Flashing:
5. Acceptable Entry Doors: Metal
6. Acceptable Garage to house Doors: Metal
7. Acceptable Sliding doors Vinyl sliding
8. Acceptable Windows: Vinyl
9. Acceptable Window glazing Double no evidence of failed seals at the time of inspection
10. Acceptable Basement Windows: vinyl
11. See Comments Caulking Horizontal joists in siding materials crawlspace vents are not flashed over; recommend caulking to prevent water ingress

5. **First Floor Exterior Surface Type:** Stucco Minor cracks
6. **Fascia:** Wood Paint peeling, Recommend paint/stain to extend the life of the component
7. **Caulking** Horizontal joists in siding materials crawlspace vents are not flashed over; recommend caulking to prevent water ingress

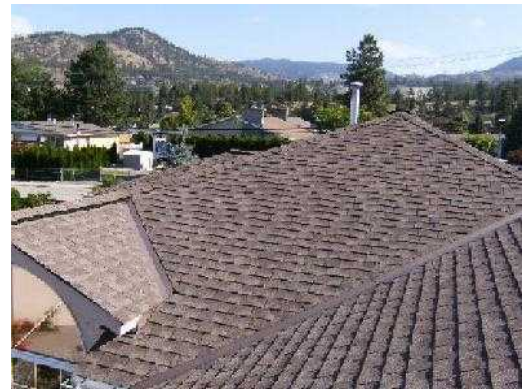
Main Roof Surface

1. Method of Inspection: On roof

2. See Comments **Material:** Asphalt shingle exposed nail heads should be covered with tabbing to prevent rusting and leaking

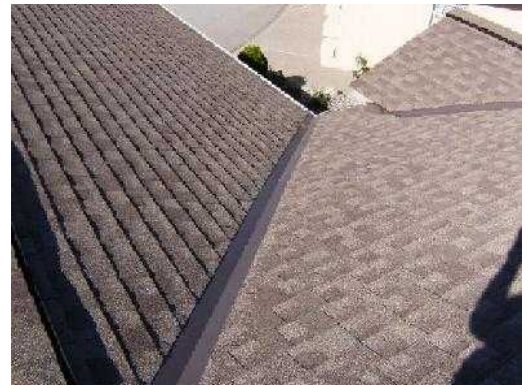
6. Acceptable **Valleys:** aluminium

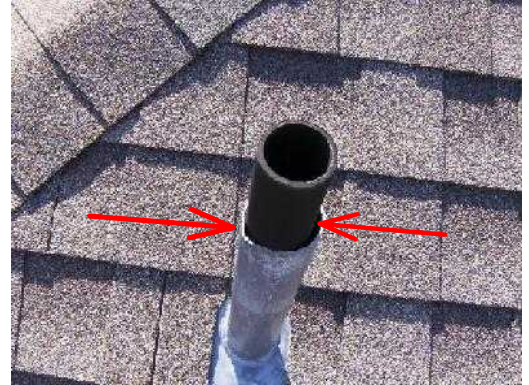
8. See Comments Plumbing Vents: ABS vent cap recommended to prevent moisture enter around vent pipe

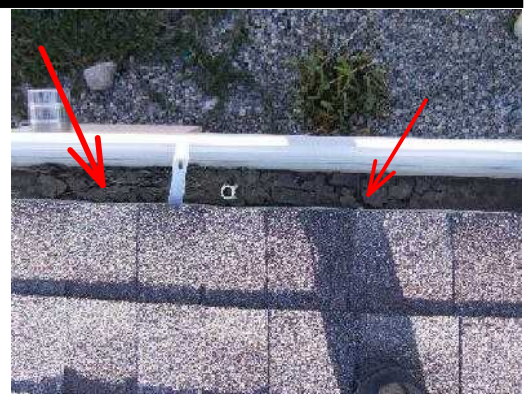
9. See Comments Gutters: Aluminum Need cleaning

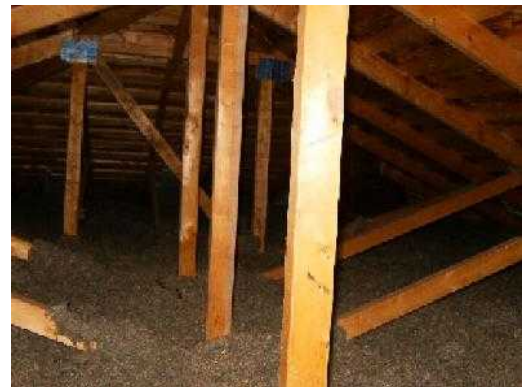
Main roof Attic

1. Method of Inspection: From the attic access

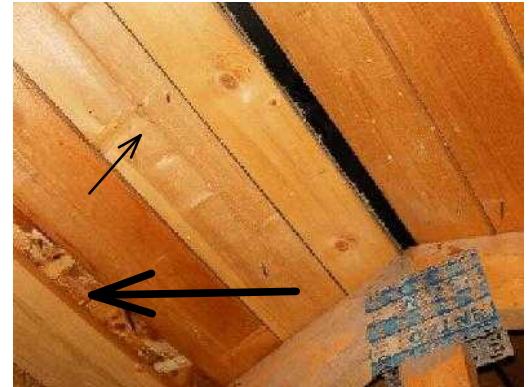
2. Acceptable **Roof Framing:** 2x4 Truss
 3. Acceptable **Sheathing:** Dimensional wood, OSB

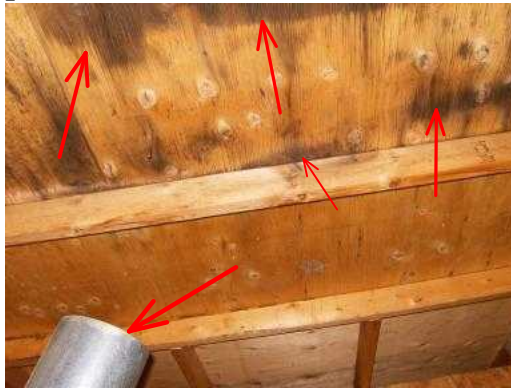
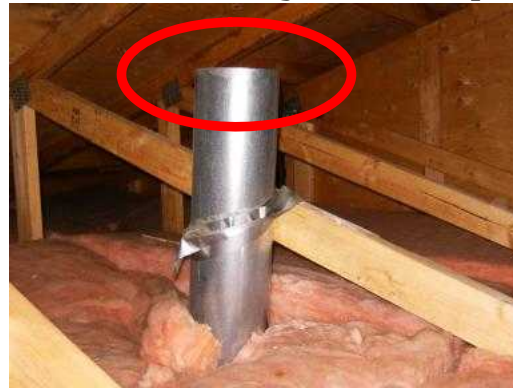
4. Acceptable **Ventilation:** Ridge and soffit vents
 5. Acceptable **Insulation:** Blown in, Cellulose
 6. See Comments **Insulation Depth:** 8" Consider adding more insulation in the attic to improve the energy efficiency of the home.
 7. Acceptable **Vapor Barrier:** Sheet plastic
 8. Defective **Bathroom/kitchen Fan Venting:** Solid/smooth duct Bathroom improperly vents into attic and may cause moisture damage to the insulation, Recommend correction, Recommend adding duct wrap insulation to the duct to prevent condensation on the duct and resulting moisture problems

11. **Main roof Attic Insulation Depth:** 8" Consider adding more insulation in the attic to improve the energy efficiency of the home.

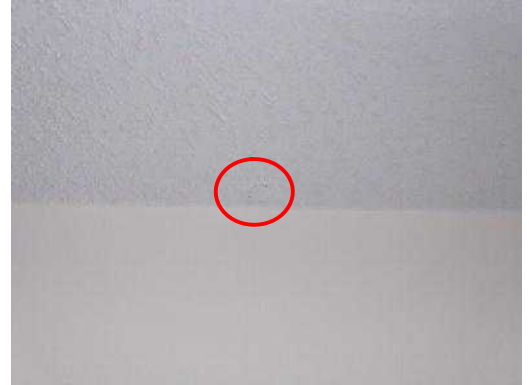
2. See Comments Ceilings: Drywall, Textured minor nail pops

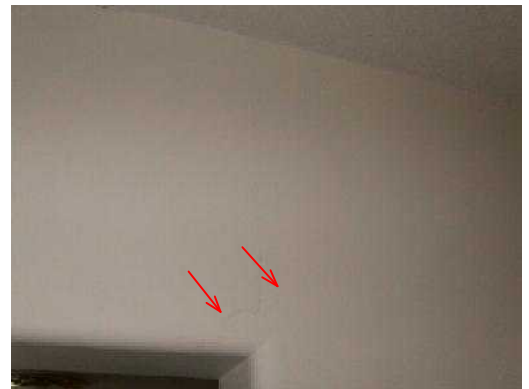
3. See Comments Walls: Drywall minor stress cracks

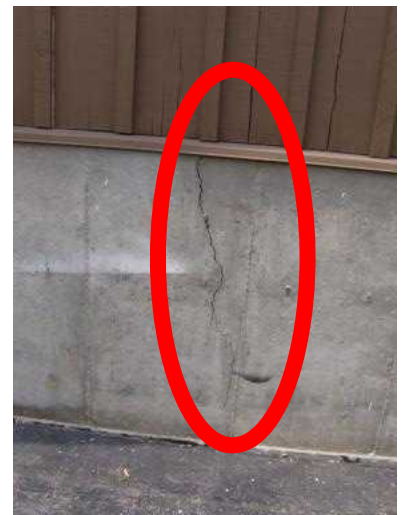
- 1. Acceptable **Structure Type:** Wood frame, only partially visible
- 2. See Comments **Foundation:** Poured concrete Cracked with displacement, Recommend monitoring for further movement/cracking, and repair as needed

21. **Foundation:** Poured concrete Cracked with displacement, Recommend monitoring for further movement/cracking, and repair as needed
22. **Bearing Walls:** Frame main floor construction is concealed behind finishes, not inspected
23. **Floor/Slab:** crawlspace floor-skim coat minor shrinkage cracks

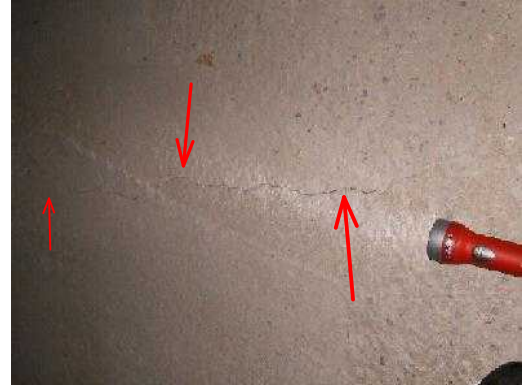
- 4. Acceptable Joists/Trusses: "I" joist 10" nominal @ 12" o/c
- 5. See Comments Floor/Slab: crawlspace floor-skim coat minor shrinkage cracks

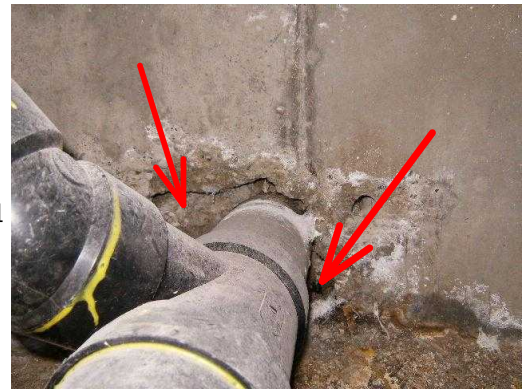
- 1. Method of Inspection: Traverse of crawlspace
- 2. Acceptable Access: Floor hatch
- 3. Marginal Moisture Penetration: damp soil and efflorescence at sewer pipes exit through wall location where building sewer pipe exits through the concrete foundation; area around pipe is not sealed to the concrete, soil is coming into the crawlspace as well as moisture, recommend sealing this penetration to prevent moisture and soil entering the building

3. **Moisture Penetration:** damp soil and efflorescence at sewer pipes exit through wall location where building sewer pipe exits through the concrete foundation; area around pipe is not sealed to the concrete, soil is coming into the crawlspace as well as moisture, recommend sealing this penetration to prevent moisture and soil entering the building
4. **Vapor Barrier:** sheet plastic, in box joists The box joist ends have insulation installed with a poly vapor barrier over, the poly vapor barrier is not sealed to the joists and foundation, moisture damage to the structure and insulation can be expected in these areas, recommend repairing the vapor barrier so that it performs its function and prevents moisture movement.

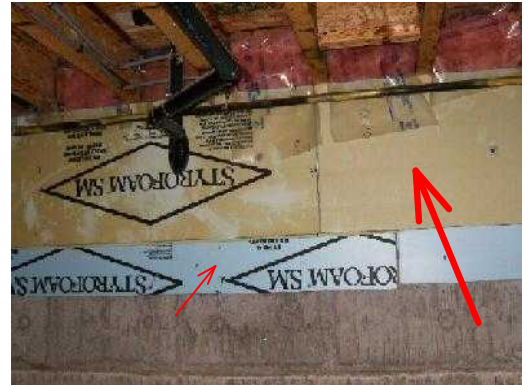
7. Acceptable Insulation: Rigid polystyrene

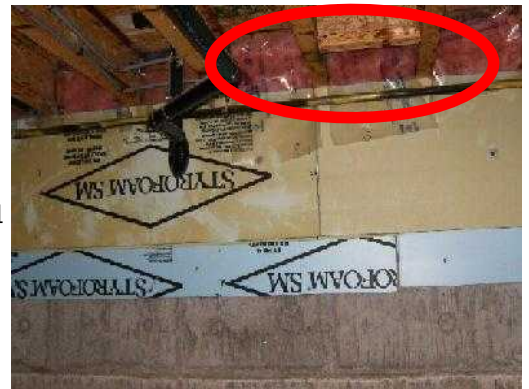
8. Marginal Vapor Barrier: sheet plastic, in box joists
 The box joist ends have insulation installed with a poly vapor barrier over, the poly vapor barrier is not sealed to the joists and foundation, moisture damage to the structure and insulation can be expected in these areas, recommend repairing the vapor barrier so that it performs its function and prevents moisture movement.

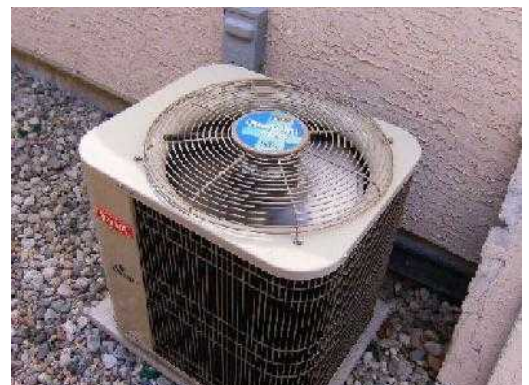
- 1. Acceptable A/C System Operation: Unit responds to controls
- 2. Acceptable Condensate Removal: Plastic tubing
- 3. Acceptable Exterior Unit: Pad mounted

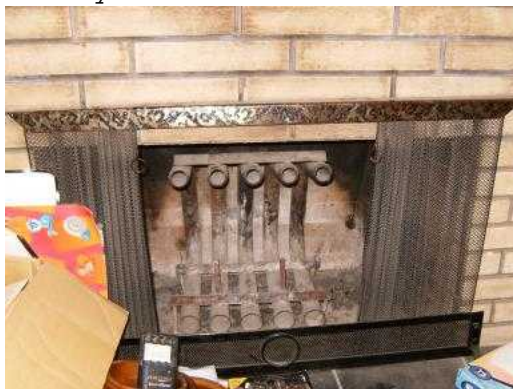
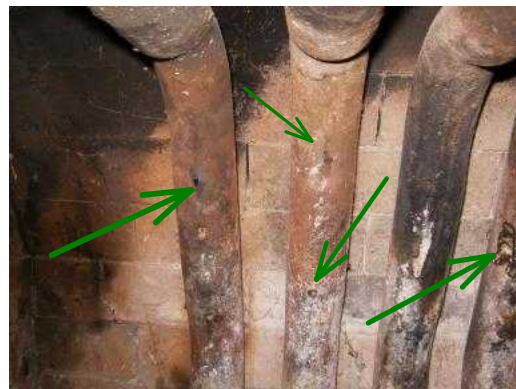
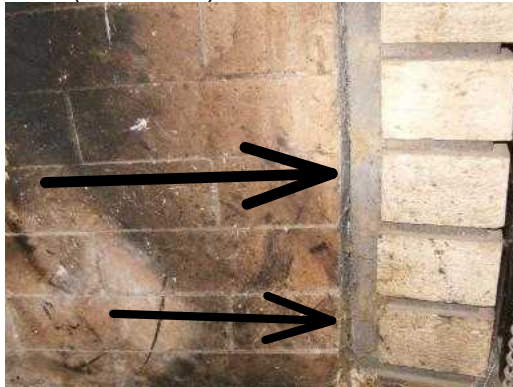
- 1. Acceptable Certification lable .n/a
- 2. Defective Fireplace Construction: Brick, c/w heatilator type system Heatilator pipes are deteriorated/rusted through, recommend removal of this system. The fir box is in serviceable condition; however the gap between the fire box and the front facing brick work is not protected with mortar, the gap leads directly to wood framing, recommend that a qualified fireplace specialist remove the heatilator system and repair the gaps. This fireplace should not be used until items are repaired, fire safety item.

3. **Family Room Fireplace Fireplace Construction:** Brick, c/w heatilator type system Heatilator pipes are deteriorated/rusted through, recommend removal of this system. The fire box is in serviceable condition; however the gap between the fire box and the front facing brick work is not protected with mortar, the gap leads directly to wood framing, recommend that a qualified fireplace specialist remove the heatilator system and repair the gaps. This fireplace should not be used until items are repaired, fire safety item.
4. **North Chimney Chimney:** Brick chimney is crack/loose at the roof line, repair/replacement required to avoid chimney falling over, do not use the fireplace until the chimney is repaired, fire safety item

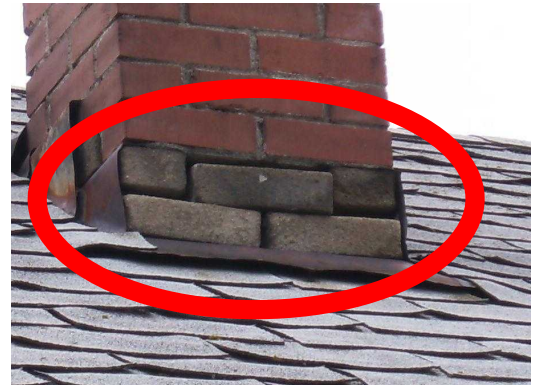
7. Defective

Chimney: Brick chimney is crack/loose at the roof line, repair/replacement required to avoid chimney falling over, do not use the fireplace until the chimney is repaired, fire safety item

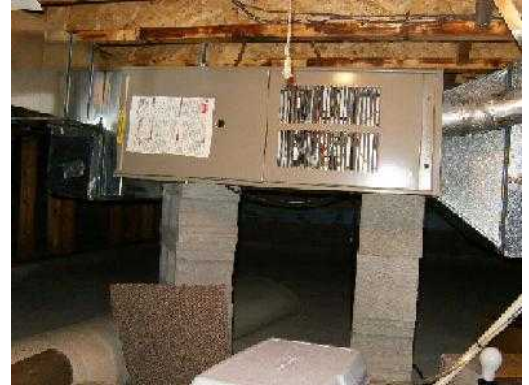
2. Manufacturer: Goodman

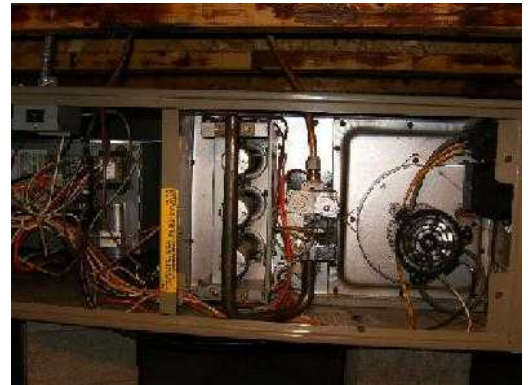
- 3. Model Number: gmp075-3 Serial Number: 9603817550
- 4. Type: Forced air Capacity: 60,000 BTU
- 5. Area Served: Whole building Approximate Age: 2003
- 6. Fuel Type: Natural gas
- 7. Acceptable Heat Exchanger: 3 Burner, only partially visible

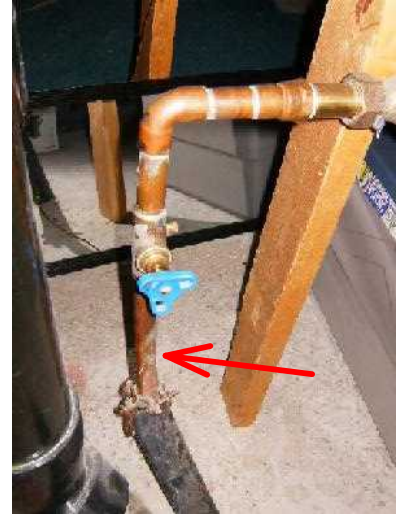
1. Acceptable Service Line: Copper

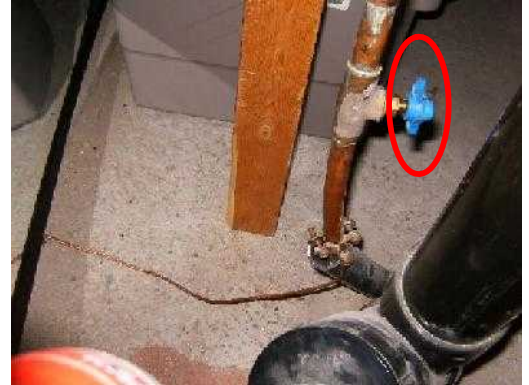
2. Acceptable Main Water Shutoff: Crawlspace

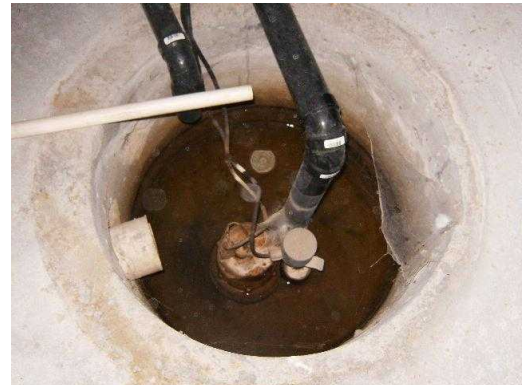
3. Acceptable Water Lines: plastic, ABS, Copper, partially concealed
4. Acceptable Vent Pipes: ABS, only visible at roof
5. Acceptable Drain Pipes: ABS, partially concealed
6. Acceptable Kitchen Sink: Stainless Steel, Double
7. Acceptable Bathroom Sink/Basin: Porcelain coated
8. Acceptable Faucets/Traps: Operational
9. Acceptable Sump Pump: Submerged

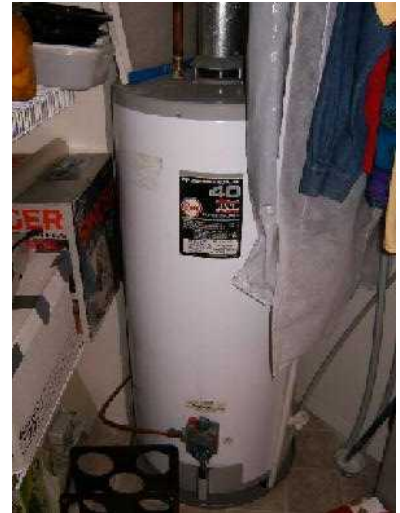
13. Acceptable **Water Heater Operation:** Functional at time of inspection Water heater is nearing the end of it's design life

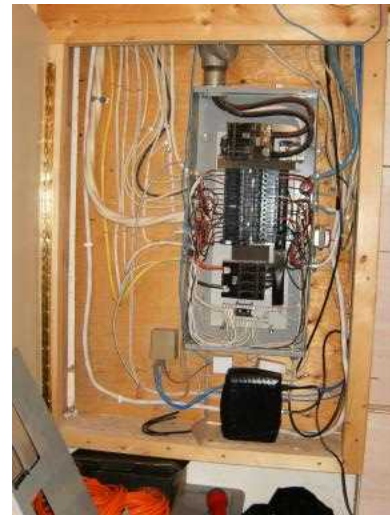
- 1. Acceptable Service Entrance: Under ground utilities
- 2. **Service Size Amps:** 200 **Volts:** 110-240 VAC
- 3. Acceptable Service: Aluminum
- 4. Acceptable Ground: Plumbing ground only
- 5. Acceptable Conductor Type: NMS cable
- 6. Acceptable Circuitry Copper
- 7. Acceptable Interior Lighting: 110 VAC
- Garage Electric Panel**
- 8. Acceptable Manufacturer: Seimens
